Trail Survey: Upper Ballard Trail

25 April, 2021

Stephen Flanders, volunteer

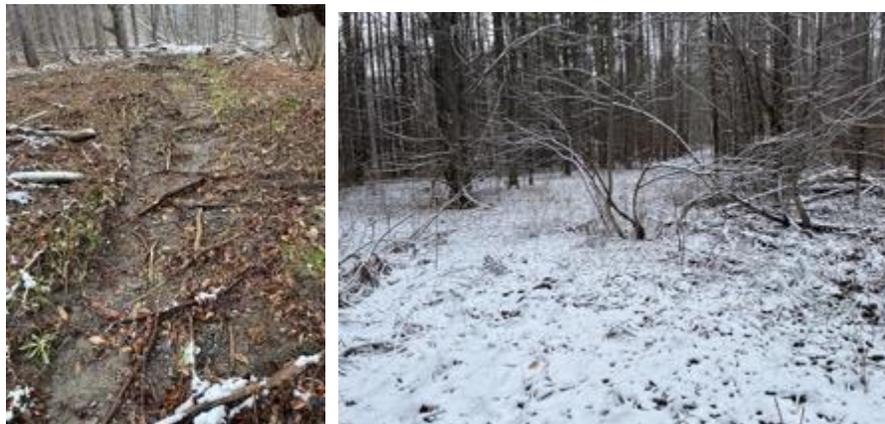
Perennially flooded area—The area at [43.744831, -72.350486](#), downstream of the Grand Canyon crossing where one steps across a fallen apple tree, is subject to overland flow, which has eroded the treadway and is impassable at high water. A relocation is indicated.

[Frequently flooded area](#) (l.) and [proposed trail relocation](#) (r.)—to the left when facing upstream

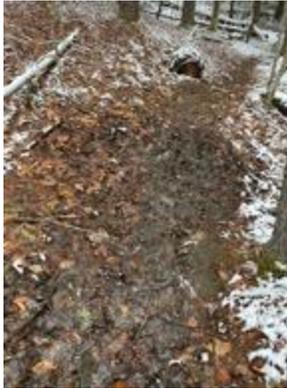
- [Wet Area #1](#): Located at [43.738956, -72.345756](#).

Puncheon candidate areas—I distinguish “puncheons” from “bog bridges” by the following: Puncheons are made from a log sliced length-wise and mounted on log supports, whereas bog bridges are made from dimensioned lumber. Puncheons are an alternative for areas, where carrying lumber is more laborious than harvesting a nearby tree. I recommend new puncheons at three locations:

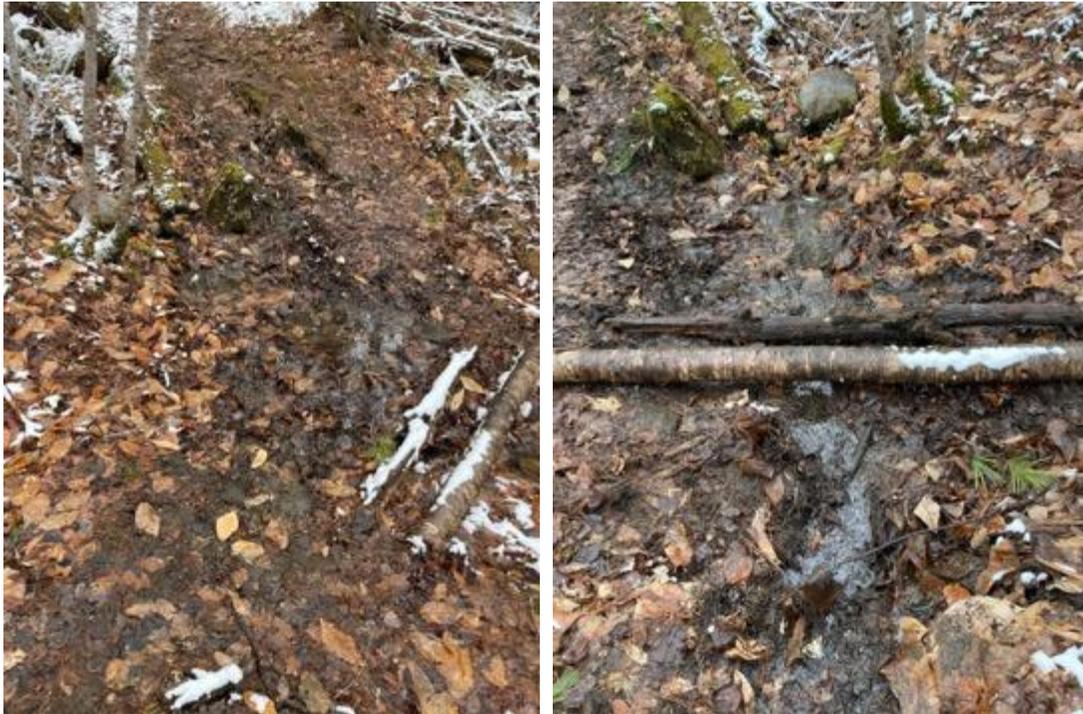
Boggy area for maintenance—I found two muddy areas where autumn leaves had obstructed runoff and created muddy areas. These, I drained using my boot to make a channel downhill through the mud. Upon my return, one had started to drain, the other appeared to need puncheons (Wet Area #1).

Wet spot at [43.738361, -72.344856](#), designated [BTSC38](#), before and after draining.

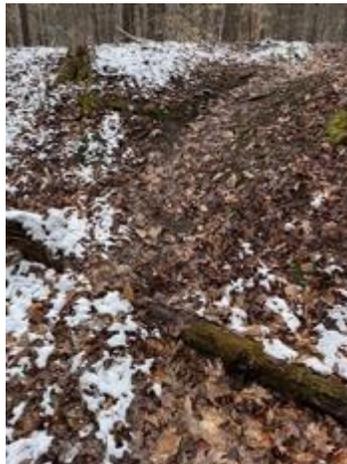
Candidate step area—I had no difficulty with traction under foot, surmounting the slope leading away from the stream at [43.744772, -72.350044](#). This has been identified as a candidate area for stone steps.

[Candidate area for steps.](#)
